ASSESSING THE UNIVERSAL DESIGN OF PEDESTRIAN FACILITIES IN THE CENTRAL AREA OF CILEGON CITY

Figure 3.1. Cilegon City Government Center Area

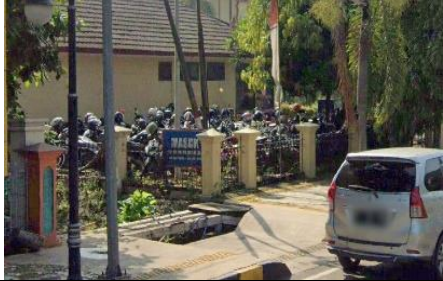
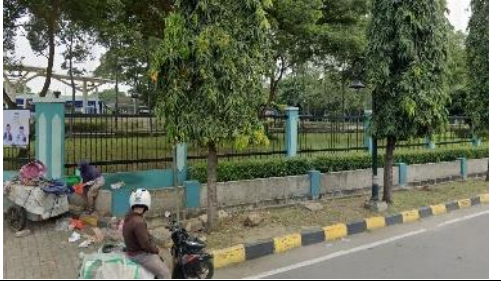
| Section | Right Side | Left Side |
|---|---|--|
| Lanes 1 | | |

| Element | Finding |
|---|---|
| A1 | Sidewalks along the length of the road have several width variations ranging from 3-metres to 1.5 meters. There is 1 spot with no pedestrian path |

After observation, it was found that the sidewalks have several issues, including varying widths ranging from 1 to 3 meters (Table 3.5). Additionally, one of the lanes lacks pedestrian infrastructure altogether. In some areas, there are intersections in the design in front of gates without proper slopes, and open drainage systems without covers.

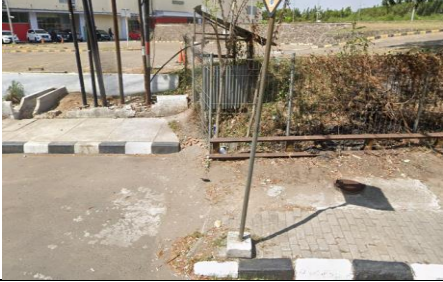
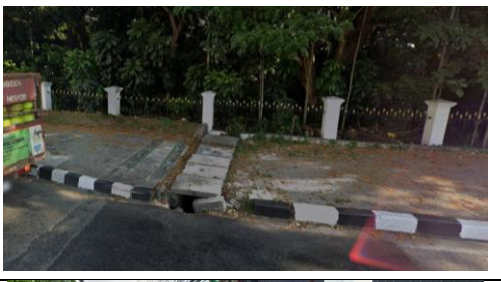
| Section | Right Side | Left Side |
|---|---|--|
| Lanes 2 | | |

| Section | Finding |
|---|---|
| A1 | The width of the road varies, with the lane adjacent to the police station facility, the pedestrian facilities can still be used while opposite the pedestrian path has been used for stalls and is only 0.8m - 1 meter wide, this is the case on KH Yasin Beji road. |

Furthermore, the construction of new and old pedestrian paths is misaligned, resulting in discontinuity between the two. This issue is further exacerbated on Jalan K.H. Yasin Beji, where street vendors occupy and obstruct the sidewalk area.

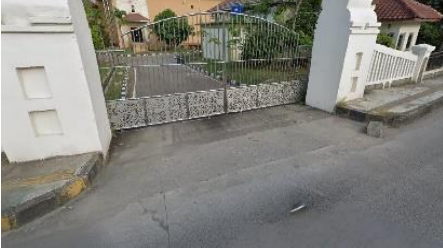
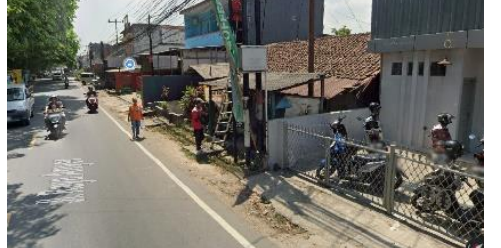
| Section | Right Side | Left Side |
|---|---|--|
| Lanes 3 | | |

| Element | Finding |
|---|---|
| A1 | Only on the side that has a pedestrian way on Jendral R. Suprpto Strat is the side adjacent to the DPRD Office and the Child Friendly Park. While on the other hand, there are no sidewalk facilities built, there are only footpaths formed from shop parking areas. |

The pavement materials used consist of three types (Table 3.5): smooth plaster with yellow-green paint, rough plaster, and paving blocks. In the area with smooth stucco, the surface becomes slippery when wet, posing a risk to users. Additionally, in lane 3, where trees grow densely and are shaded from the sun, moss has developed on the pedestrian path, which can also create slippery conditions. In the paving block area, the guiding path is not installed (Table 3.7). Furthermore, safety fences are not installed; according to the Ministry of PUPR, safety fences are not required unless pedestrian density exceeds a certain threshold, or if vehicle traffic surpasses 500 vehicles per hour. Since this area does not meet these criteria, safety fences are unnecessary. However, it is recommended that bollards be installed to provide users with a sense of security, especially along primary arterial roads.

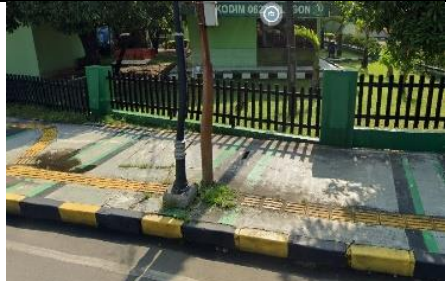
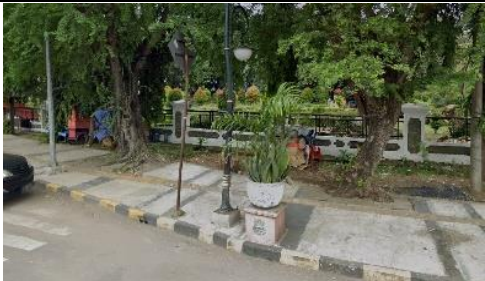
| Section | Right Side | Left Side |
|---|---|--|
| Lanes 1 | | |

| Element | Finding |
|---|---|
| A5 | The laying of the guideways is messy, not continuous with some missing spots due to passing over the top of drainage covers or hitting lampposts and trees. There is no continuous guideway as it passes through the entrance gate to the building. |

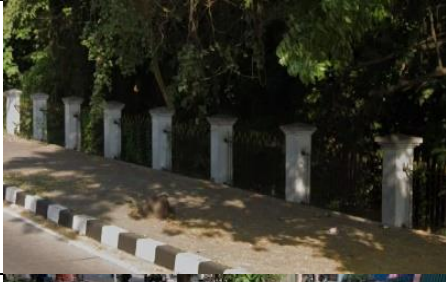
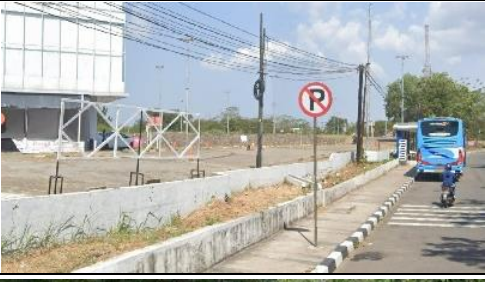
| Section | Right Side | Left Side |
|---|---|--|
| Lanes 2 | | |

| Section | Finding |
|---|---|
| A5 | Only on one side of the police office sidewalk, on the other side starting from Transmart to the front of the Cilegon City hotel area. |

Regarding speed control measures, lanes 1 and 3 do not have speed controllers because roads with primary arterial functions are not typically equipped with them. However, a speed controller should be installed if a road crossing on a primary arterial is not a tunnel or bridge. In lane 2, three-speed controllers were observed, which are needed due to the differing road levels. The guiding path has been installed, but its placement is irregular (Table 3.7) and does not meet the required standards. The directional blocks (yellow-striped tiles) should be placed along the pedestrian path with at least 60 cm of free space on each side and installed as straight as possible for easy pedestrian navigation. In areas with higher pedestrian traffic, the free space should exceed 60 cm. However, the guiding path in the field is often placed too close to building fences and obstructed by streetlamps, trees, or other objects (Table 3.7). In some locations, such as on sidewalks with block paving (Table 3.7, Lane 2), no guiding path has been installed

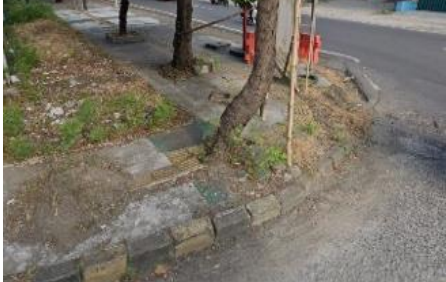
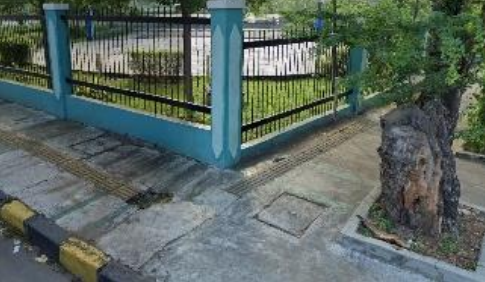
| Section | Right Side | Left Side |
|---|---|--|
| Lanes 3 | | |

| Element | Finding |
|---|---|
| A5 | Only on the built-up side of the pavement |
